# Rehabilitation in the Rocky Mountains

*Reinstating the 3.5km long Laramie-Poudre irrigation tunnel in Colorado, US, involved a wide variety of rehabilitation methods. Restricted access to the site and tunnel works combined with strict environmental constraints also created major logistical challenges. Dr Christoph Goss, resident engineer for Rocky Mountain Consultants, describes the history of the tunnel and the recent works carried out*

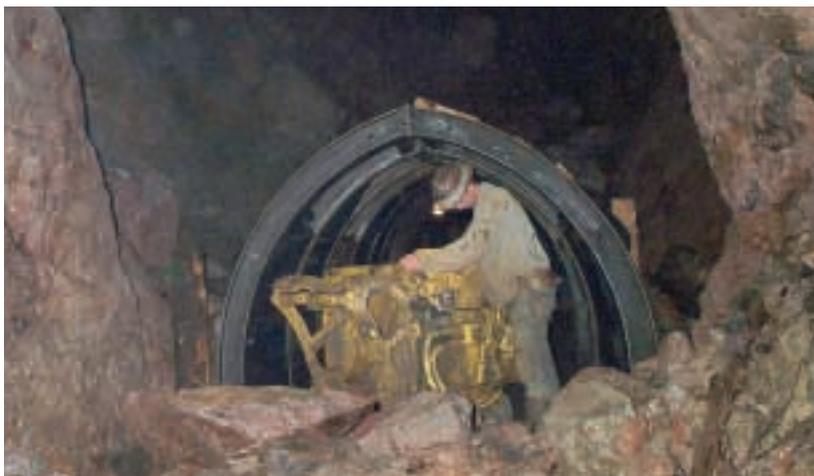
**Below: Mining out the last of the caved rubble in the cavern**

When the crews broke through on March 6, 2001, they looked back on an 18m long, 875m<sup>3</sup> cave.

Above the tunnel, the cave reached up 15m, but to the north the cave reached at least 24m before pinching out in the darkness.

The cave was too large to be filled, given the budget, equipment size and time constraints. Hence, a 2.5m thick cushion of cellular concrete grout was pumped above the fully lagged steel sets to absorb the impact of any future rockfall. The grout mixing equipment was a custom built ChemGrout CG3L6 supplied by Surecrete, Inc, while Pacific International Grout provided the foaming agent, mixing equipment, and on-site training.

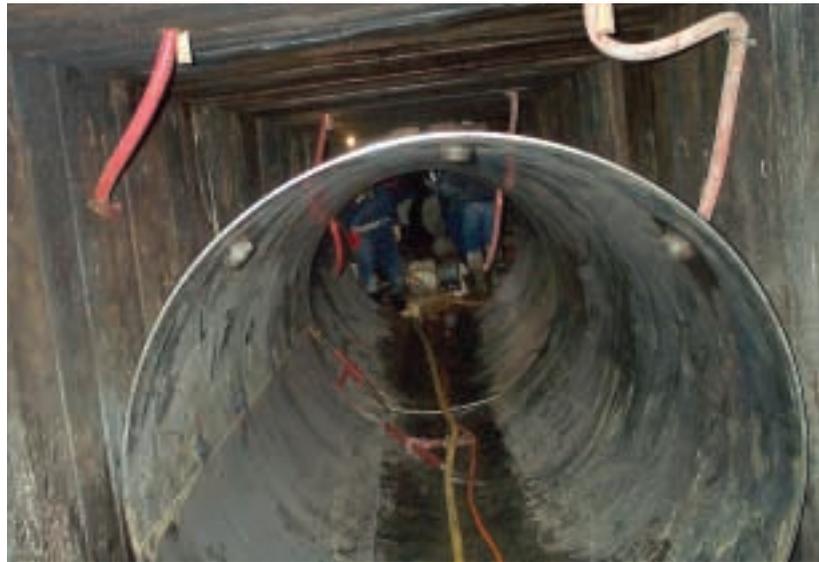
**Above: Steel pipe being expanded inside the timbered section. Note the grout hoses reaching above the timbers**

The longer timbered sections had to be repaired in place with an expandable steel pipe, placed inside the sets and grouted into place. The expandable "squash pipe" was an innovative value engineering proposal by RCI. It allowed the pipe to fit through tunnel constrictions instead of having to locally remove support and re-mine. The pipe was made of 1cm thick steel that was split longitudinally rolled together so that the ends overlapped. This compressed pipe was able to navigate tight spots within the tunnel while being moved into place with the locomotive. Once the pipe was in place, the overlapping joints were expanded to 1.6m, filling the inside of the timbers. After all the joints were welded, the ends were sealed with shotcrete bulkheads. Next, cellular concrete grout was pumped through grout ports in the upper haunches of the pipe. The grout filled both the annular space between the pipe and timber as well as the voids in the crown. 126m of tunnel was repaired in this manner.

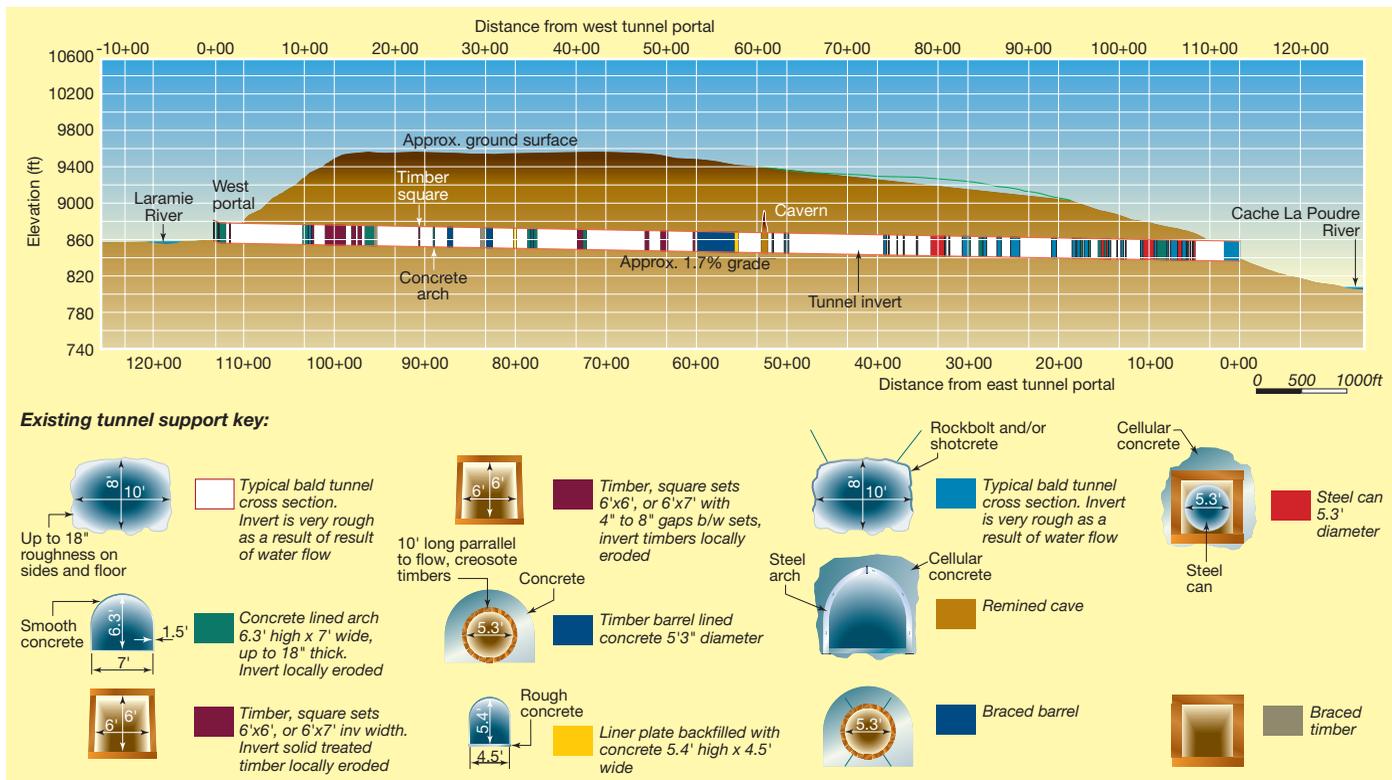
**Below: Fig 2 - Cross section of the Laramie-Poudre irrigation tunnel, showing the various types of support at the completion of Phase 2**

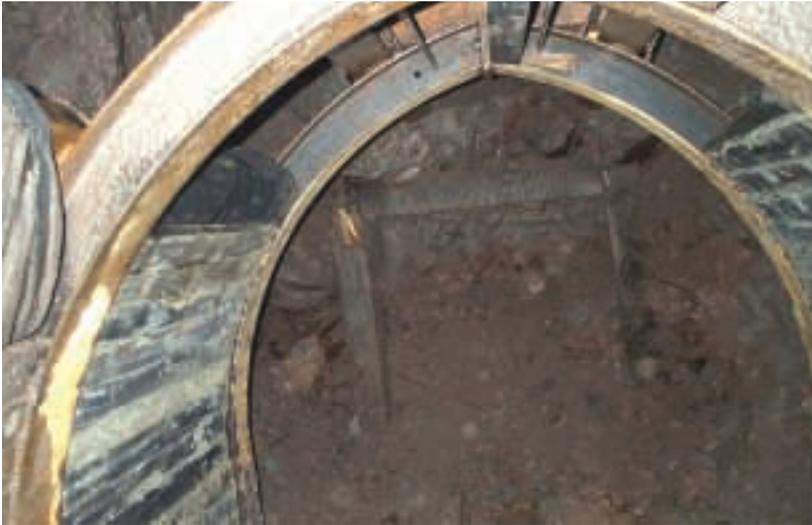
**Above: View of the face while mining through the caved area. The timber set is clearly visible within the muck**

As the face slowly advanced, W6x25 arched steel sets from American Commercial Inc. were stood every 1.2m for support. Heavy ship channel was used as crown bars to provide a canopy ahead of the face. The muck was a mixture of sand, clay, gravel and boulders ranging in size from a hat to a large bus. During the advance, the old timber sets appeared in the face. They leaned a bit to the left, but were otherwise intact within the field of muck.
