# Rehabilitation in the Rocky Mountains

*Reinstating the 3.5km long Laramie-Poudre irrigation tunnel in Colorado, US, involved a wide variety of rehabilitation methods. Restricted access to the site and tunnel works combined with strict environmental constraints also created major logistical challenges. Dr Christoph Goss, resident engineer for Rocky Mountain Consultants, describes the history of the tunnel and the recent works carried out*

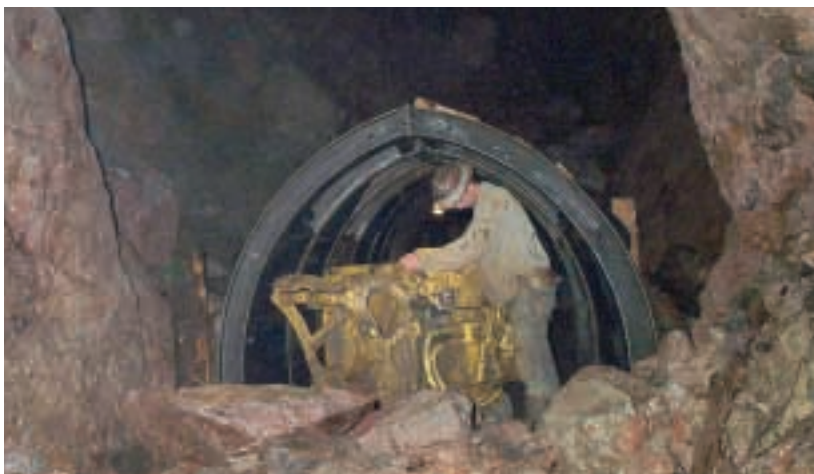
**Below: Mining out the last of the caved rubble in the cavern**

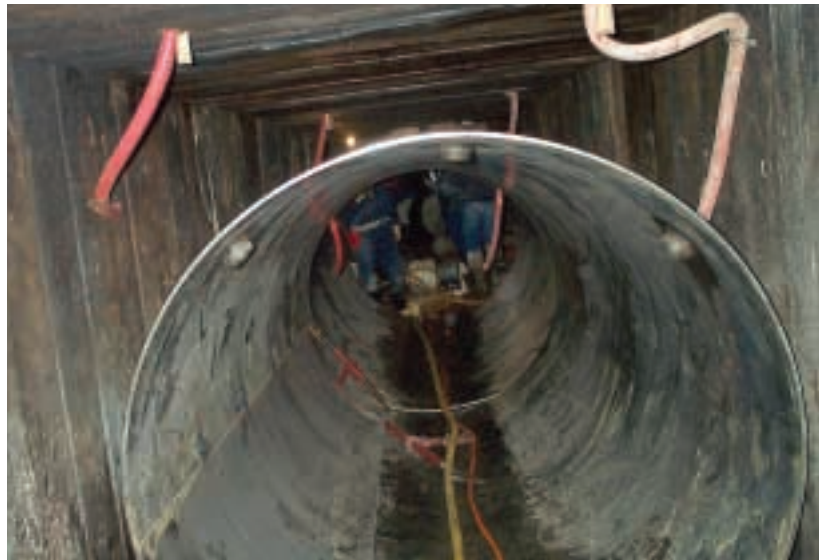
**Above: Steel pipe being expanded inside the timbered section. Note the grout hoses reaching above the timbers**

The longer timbered sections had to be repaired in place with an expandable steel pipe, placed inside the sets and grouted into place. The expandable "squash pipe" was an innovative value engineering proposal by RCI. It allowed the pipe to fit through tunnel constrictions instead of having to locally remove support and re-mine. The pipe was made of 1cm thick steel that was split longitudinally rolled together so that the ends overlapped. This compressed pipe was able to navigate tight spots within the tunnel while being moved into place with the locomotive. Once the pipe was in place, the overlapping joints were expanded to 1.6m, filling the inside of the timbers. After all the joints were welded, the ends were sealed with shotcrete bulkheads. Next, cellular concrete grout was pumped through grout ports in the upper haunches of the pipe. The grout filled both the annular space between the pipe and timber as well as the voids in the crown. 126m of tunnel was repaired in this manner.

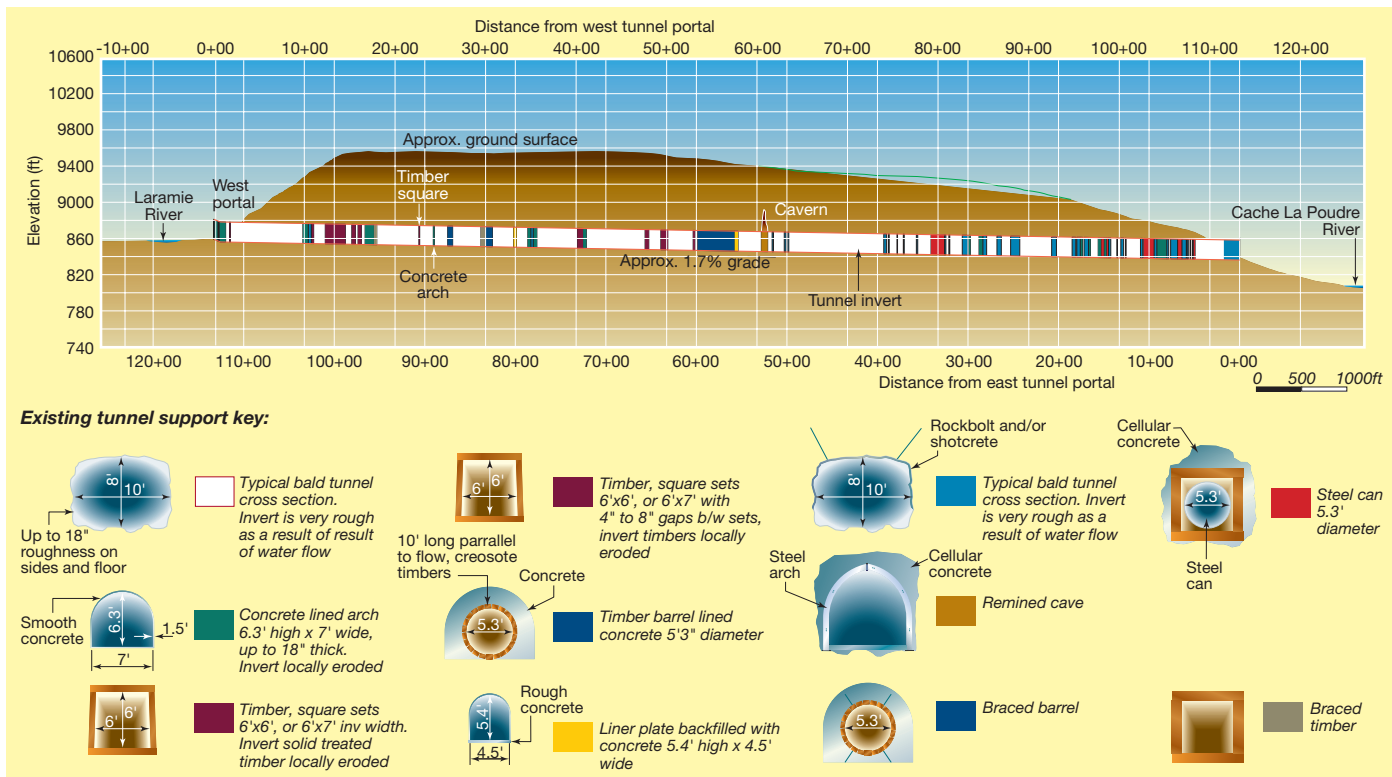
**Below: Fig 2 - Cross section of the Laramie-Poudre irrigation tunnel, showing the various types of support at the completion of Phase 2**

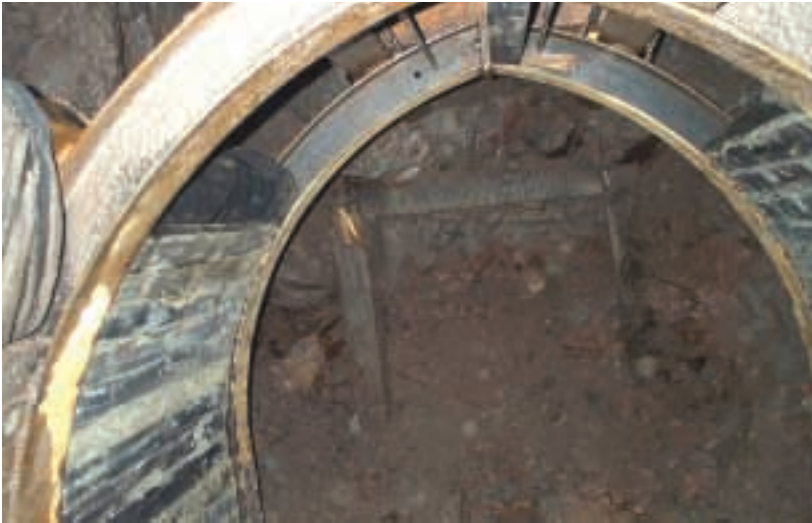
**Above: View of the face while mining through the caved area. The timber set is clearly visible within the muck**

As the face slowly advanced, W6x25 arched steel sets from American Commercial Inc. were stood every 1.2m for support. Heavy ship channel was used as crown bars to provide a canopy ahead of the face. The muck was a mixture of sand, clay, gravel and boulders ranging in size from a hat to a large bus. During the advance, the old timber sets appeared in the face. They leaned a bit to the left, but were otherwise intact within the field of muck.

The cave was too large to be filled, given the budget, equipment size and time constraints. Hence, a 2.5m thick cushion of cellular concrete grout was pumped above the fully lagged steel sets to absorb the impact of any future rockfall. The grout mixing equipment was a custom built ChemGrout CG3L6 supplied by Surecrete, Inc, while Pacific International Grout provided the foaming agent, mixing equipment, and on-site training.
