Rehabilitation at Standley Lake

Christoph Goss, of Deere & Ault Consultants Inc, describes the tunnelling works undertaken to facilitate the Standley Lake Rehabilitation Project, which recently won an Engineering Excellence Award by the American Council of Engineering Companies (Colorado)

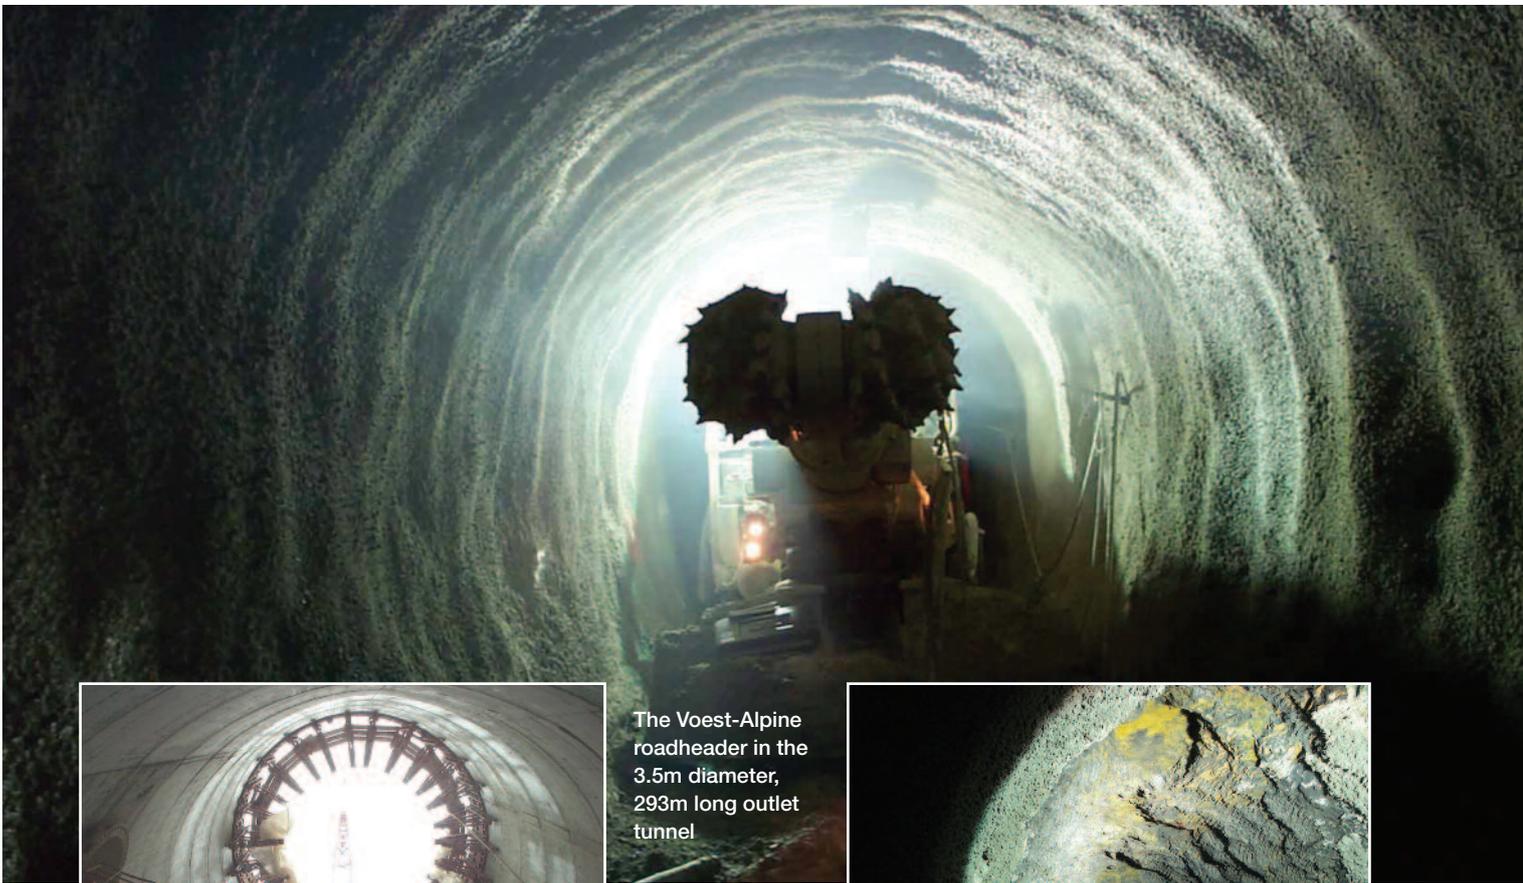
The Voest-Alpine roadheader in the 3.5m diameter, 293m long outlet tunnel

Excavation of the 3.5m diameter 293m long modified horseshoe outlet tunnel started in January 2003. The tunnel was driven west, towards the shaft, by a Voest-Alpine ATM-50 roadheader supplied by Antraquip. Muck was removed with an LHD and stockpiled on the north side of the portal area for later incorporation into the toe berm. The tunnel advance rate for 142 working days was approximately 2m per day. The tunnel holed out into the valve shaft in August 2003.

Most of the tunnel, 258m, was supported with 100mm of steel fibre reinforced shotcrete (type I support). The remaining 35m near the portal and at the valve shaft, was supported with a combination of a 150mm thick layer of shotcrete and lattice girders on 1.2m centres (type II support).

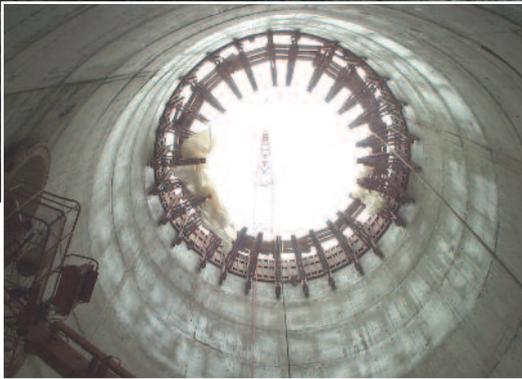
Left: View up the main shaft

Valve shaft excavation began in September 2002 using a trackhoe with a bucket and a trackhoe with a hoe ram. Spoil was placed into a skip and lifted out of the shaft and dumped north of the shaft for eventual use in the random fill east of the existing dam. As shaft excavation proceeded the sides were trimmed to a minimum diameter of 12.2m. Shotcrete, some 250mm-380mm thick, was applied over the exposed bedrock within two to three hours. A second layer of was placed to secure heavy steel rings (ribs) and

complete the shaft wall shotcrete thickness to 750mm. Twenty-four rows of 3m and 2.4m long rock dowels were installed between the steel rings with a percussion drill. After reaching the bottom, steel reinforcement was placed and the final concrete lining was placed using slip forms.

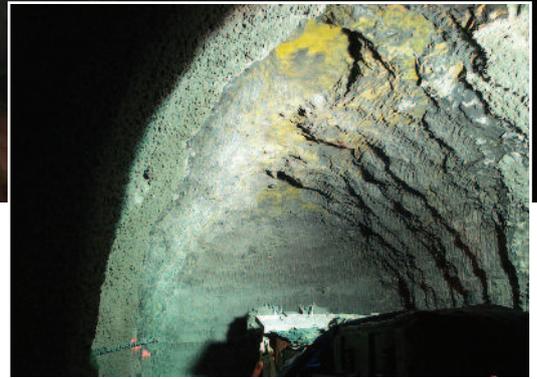
Right: Slickensides in the tunnel crown

The ground was primarily claystone of varying degrees of sandiness. The upper layers tended to be more weathered and were typically lighter coloured with iron-stained joints. As overburden increased, the claystone became more grey and massive. Shears, slickensided joints, and small coal seams and inclusions were common. Towards the shaft, a dark grey bed of carbonaceous claystone was encountered. Bedding plane features typically of thin sandy joints horizontal or dipping gently east were common. Other joints tended to be discontinuous. In several locations, block fallout on slickensided joints in the tunnel crown led to overbreaks of up to 1m.

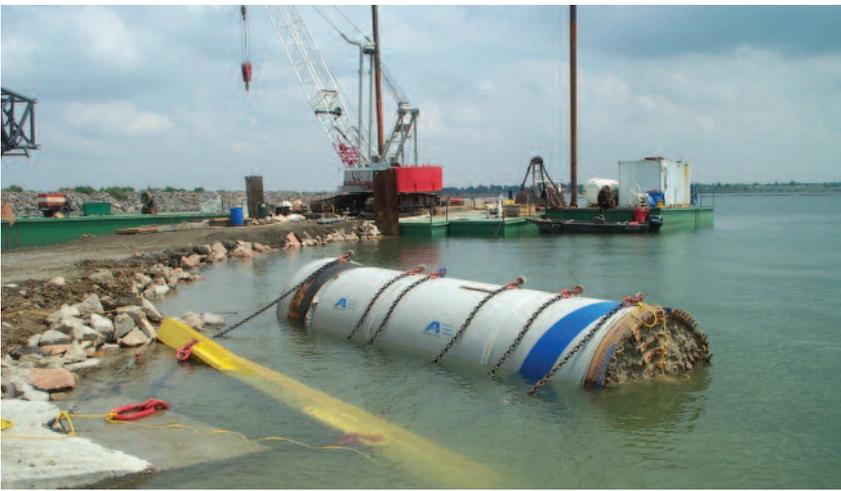
Above: The Akkerman MTBM about to be recovered by crane after the successful lake tap

The new 250 horsepower Akkerman MTBM was outfitted with carbide tipped picks and scrapers and had a 190mm overcut. The MTBM was advanced using a set of four 400t jacks and jacking frame pushing off of a thrust block on the heavily reinforced concrete shaft wall. Jacking forces were reduced by pumping bentonite through ports into the space between the pipe and ground. The pipe used in the intake tunnels was 1890mm o.d. 190mm thick Permalok steel pipe (type 7), with gasketed joints and a polymer coating on the exterior.
